**Tabulations of Propagation Data
Over Irregular Terrain in the
75- to 8400-MHz Frequency Range
Part V: Virginia**

**George A. Hufford
Francis K. Steele**

TABULATIONS OF PROPAGATION DATA OVER IRREGULAR TERRAIN IN THE 75- TO 8400-MHz FREQUENCY RANGE

Part V: Virginia

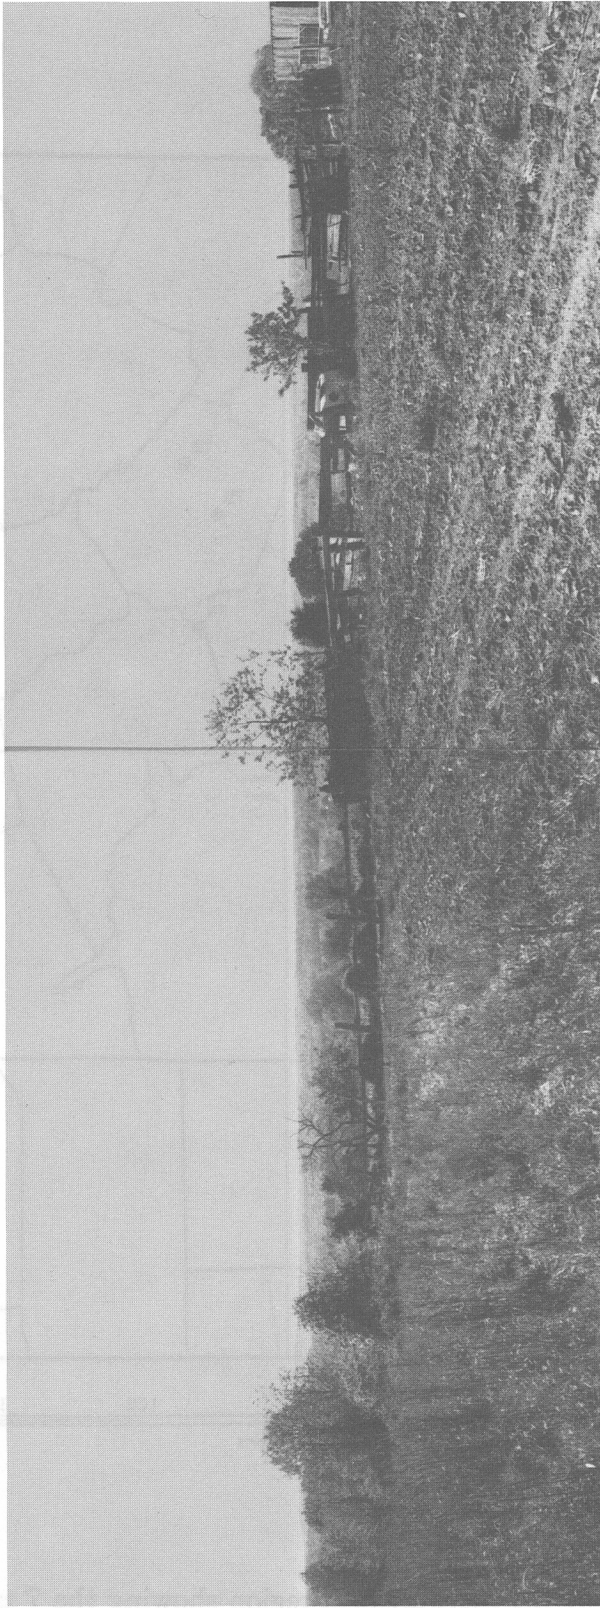
Figure 1. A view from the transmitter site T7.

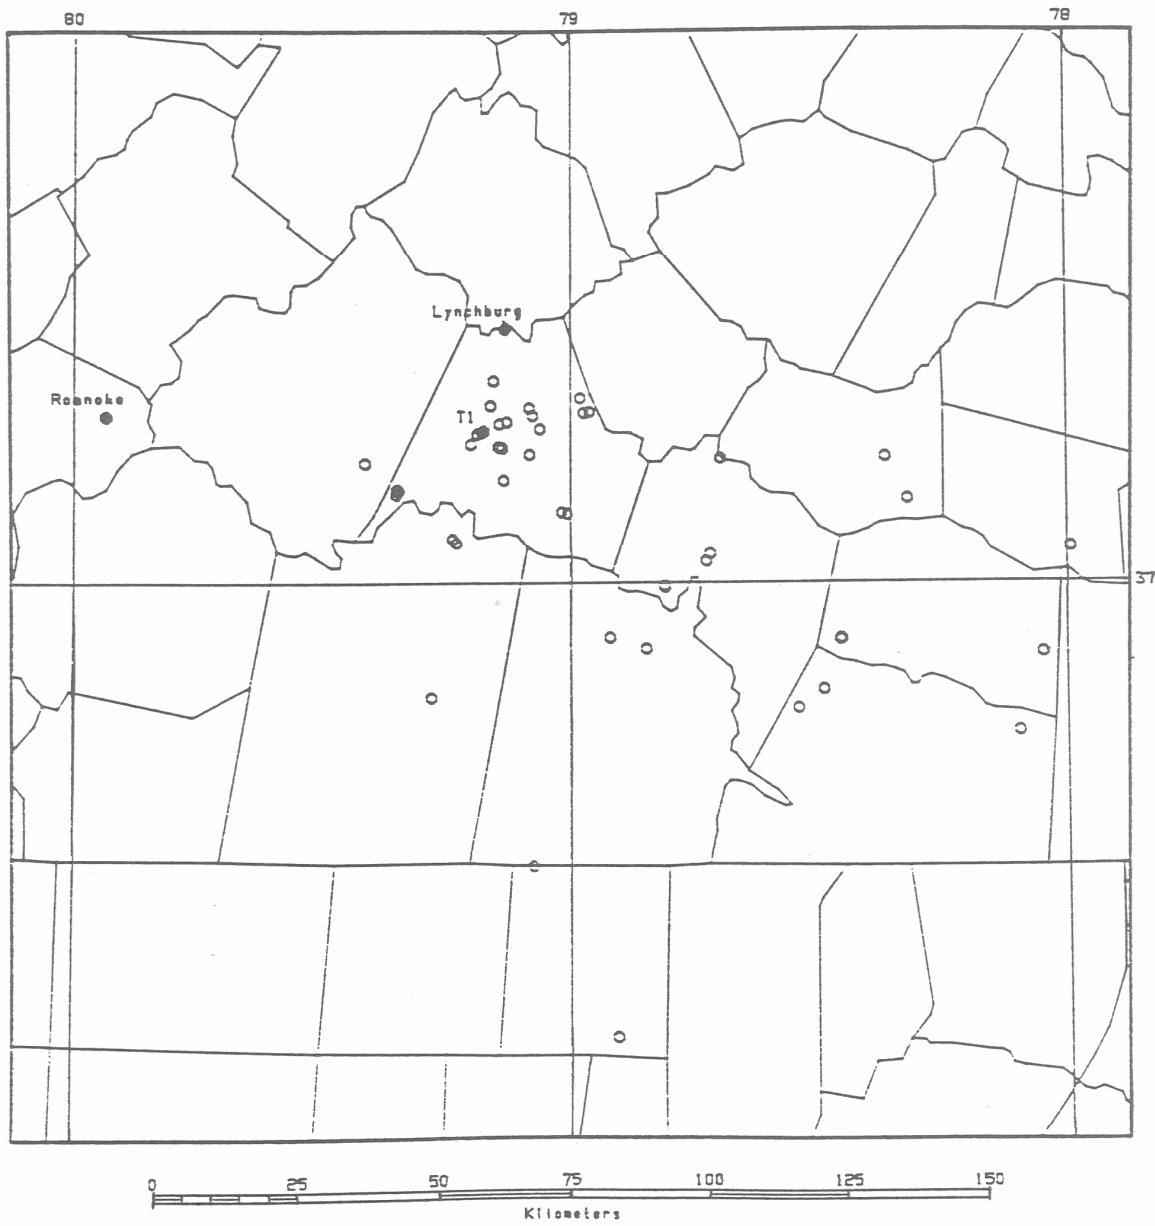
Figure 3. A map of the measurement region showing the transmitter site T1 and its associated receiver sites.

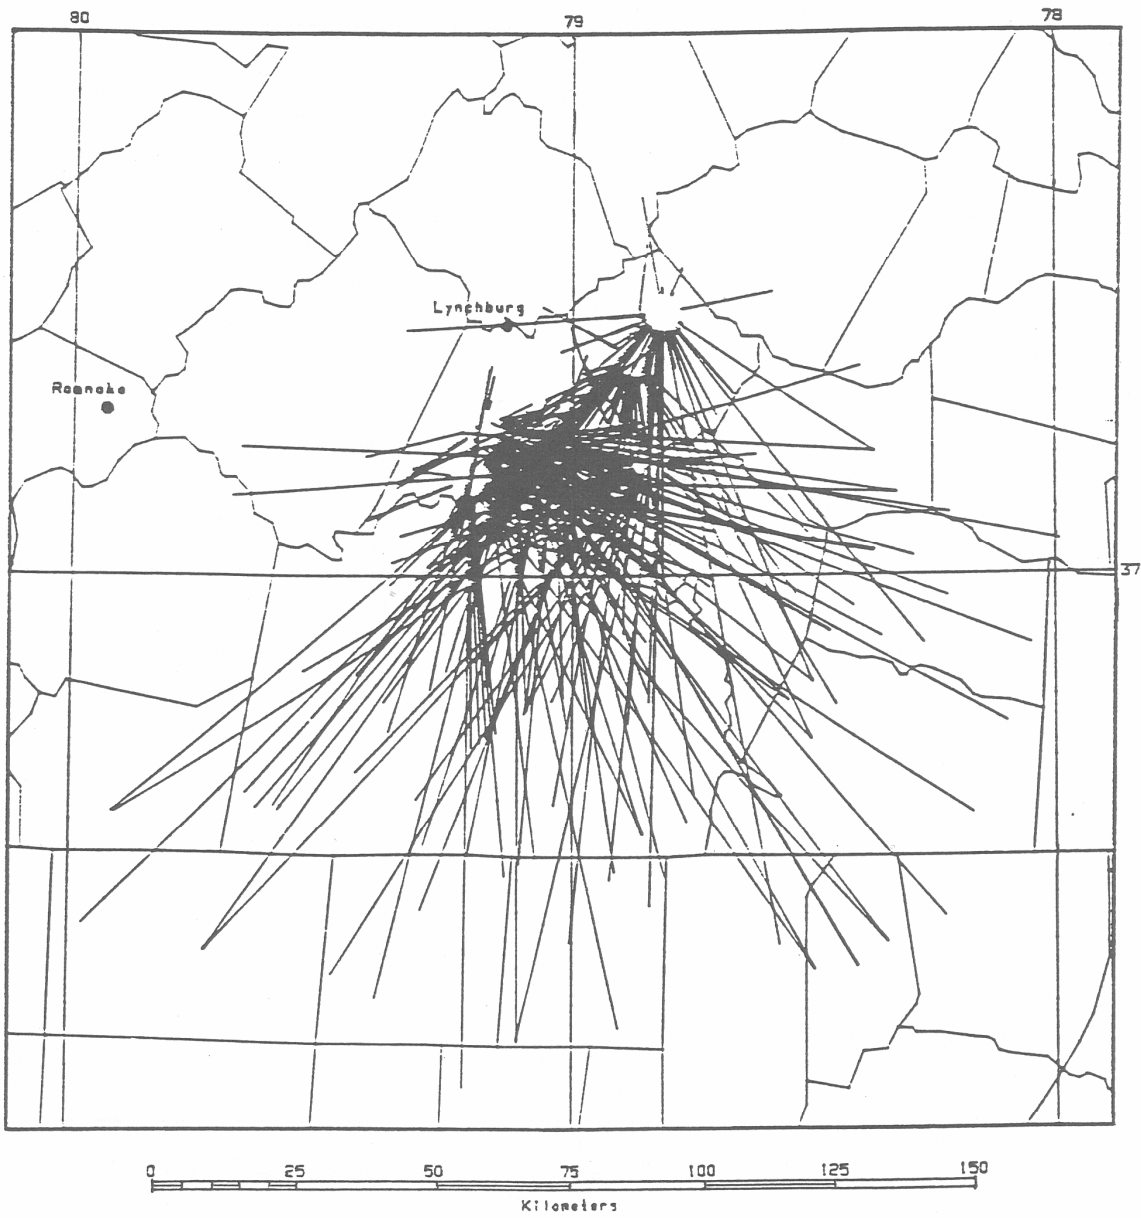
Figure 4. A map of the measurement region showing most of the 283 propagation paths.

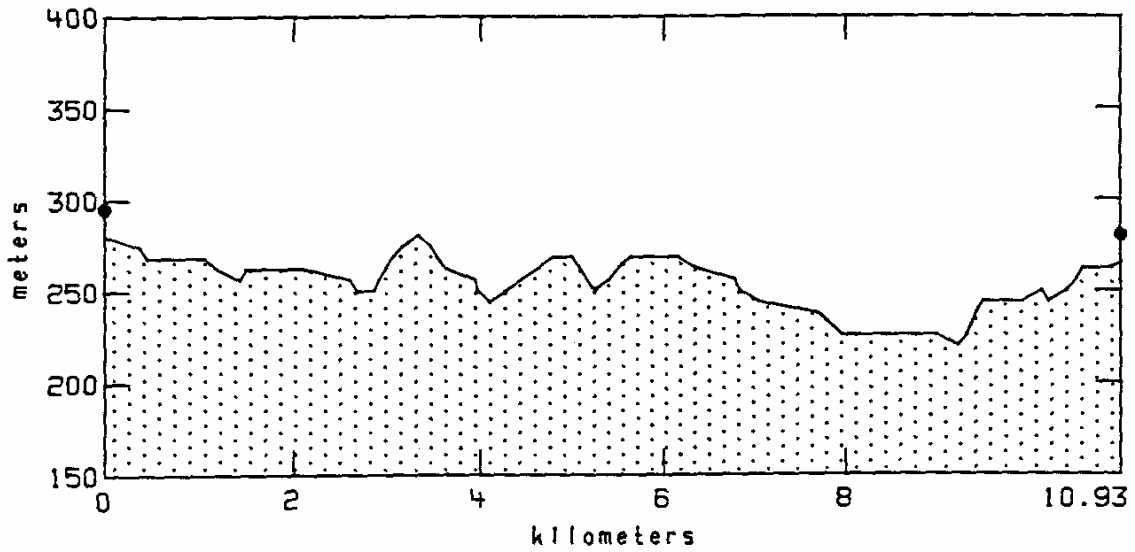
T1-10-R4

Path length, 10.93 km

The site is in a pasture. There are large oak trees about 300 m from the antennas.
