# **Building Penetration Loss Measurements at 900 MHz, 11.4 GHz, and 28.8 GHz**

**K.C. Allen  
N. DeMinco  
J.R. Hoffman  
Y. Lo  
P.B. Papazian**

May 1994

**BUILDING PENETRATION LOSS MEASUREMENTS  
AT 900 MHZ, 11.4 GHZ, AND 28.8 GHZ**

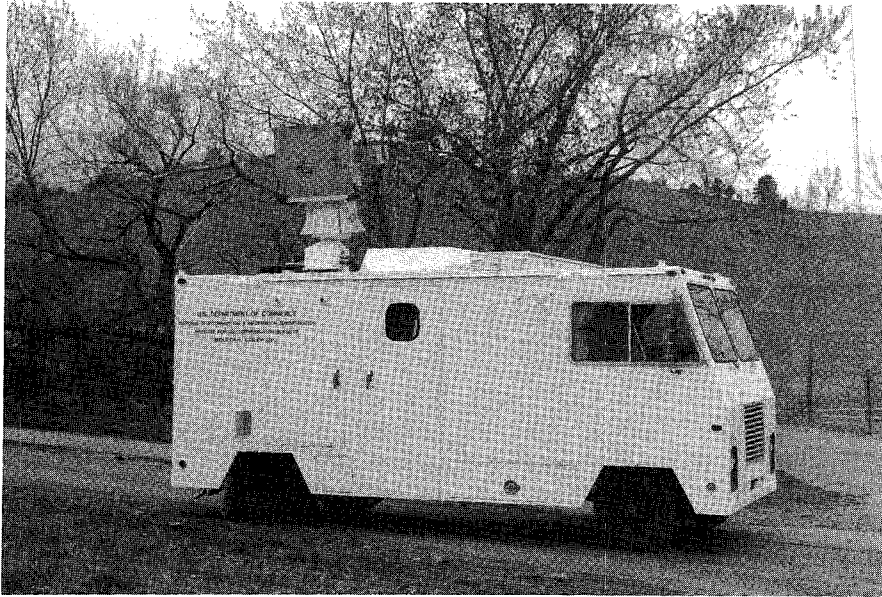
Figure 1. ITS millimeter-wave measurement van (receiver).

The measurement system included three transmitters mounted on a cart that could be moved inside buildings, and the ITS millimeter-wave van located outside the building for reception of the signals. The van is shown in Figure 1 and the transmitter cart is shown in Figure 2. The transmitter cart consisted of three separate calibrated signal generators connected to three separate antennas. The antennas on the cart were omnidirectional in the azimuthal plane to simulate the radiation coverage typical of the small antenna that would be used for a PCS handheld unit. The receiving antennas on the van consisted of two medium-gain horn antennas with 17 dBi at 11.4 GHz and 16 dBi at 28.8 GHz both with vertical polarization, and a vertically-polarized omnidirectional antenna at 900 MHz. The beamwidths in azimuth and elevation of the 11.4-GHz horn were both 22 degrees, and the beamwidths for the 28.8-GHz horn were both 25 degrees. The horn antennas provided adequate angular coverage for receiving most of the multipath signals radiated from the transmitters inside the buildings under test, but favored the direct path and multipath signals arriving within their beamwidths.

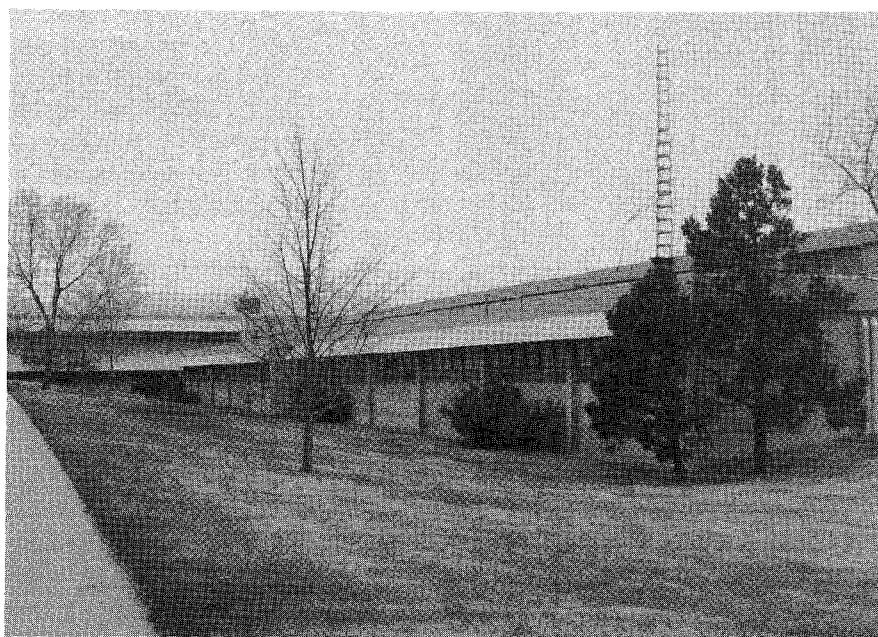
Figure 4. West side of Wing 4 of the Radio Building.

offices cover approximately 6 m<sup>2</sup>. Figure 4 is a view of the west side of Wing 4 showing these windows. All offices in Wing 4 have these windows, and as a result the building may be relatively transparent to the electromagnetic energy from the signal sources when the van was positioned on the side of the building. The office doors are of wood construction with approximately 2.3 m<sup>2</sup> of area. The rooms are filled with conventional metal office furniture including desks, file cabinets, tables, and chairs.

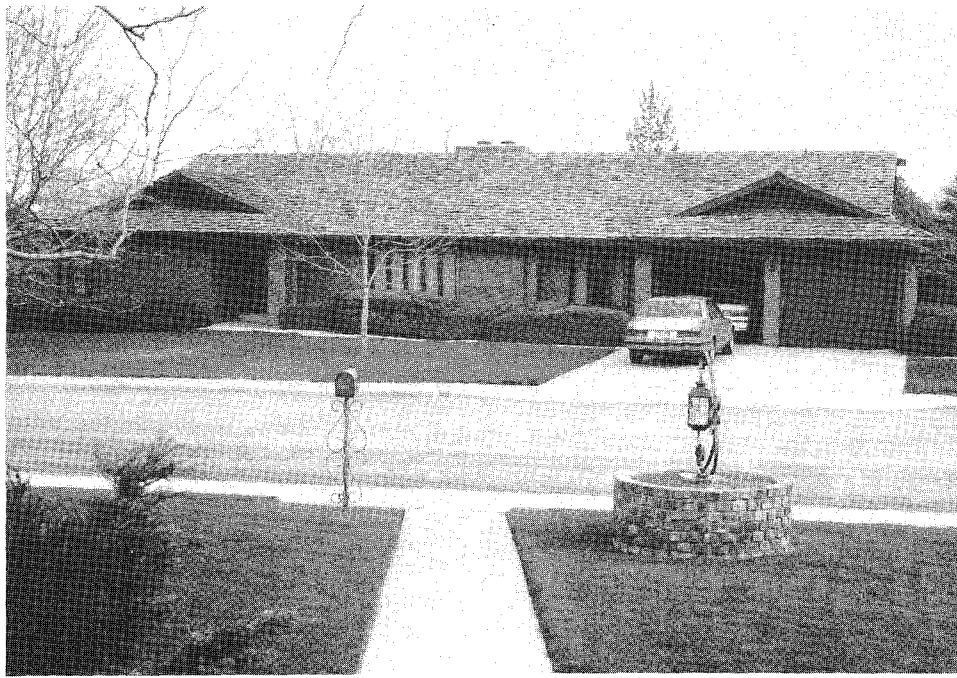
Figure 5. Private residence.

The building shown in Figure 5 is a standard wood-frame house with brick veneer on the outside. The gypsum wallboard did not have a metallic foil on one side. The insulation has a paper vapor barrier. The furniture inside this structure is predominantly of wood and non-metallic construction typical of a private residence. The shrubbery and trees outside did not obstruct the line-of-sight between the transmitter and receiver. Window area on the street side of the house was approximately 4 m<sup>2</sup> per room. There were two major paths traversed during the measurement. One interior wall separated the two paths. The rear path had the exterior wall plus an interior wall between the receiver and transmitter. The front path had just one exterior wall between the receiver and the transmitter.

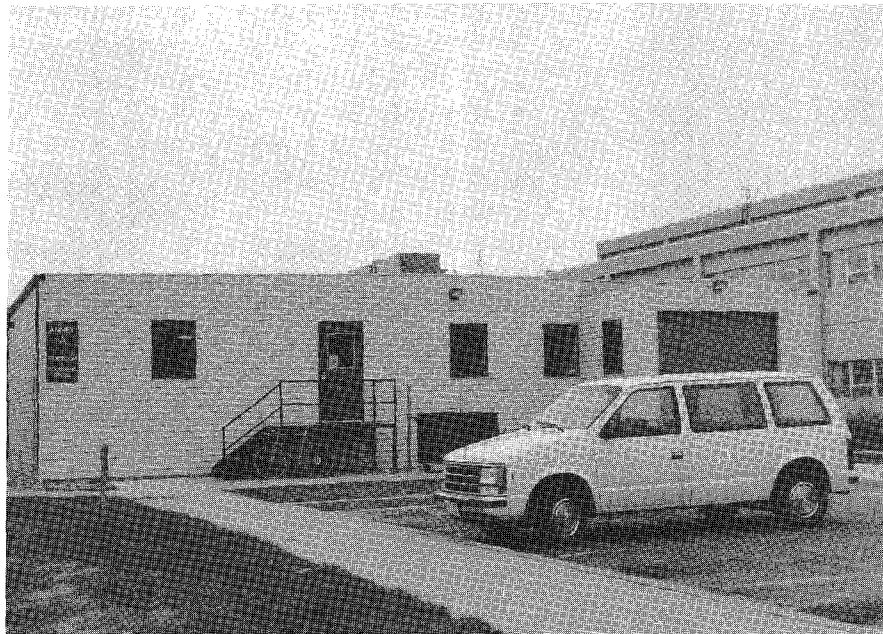
Figure 6. Storeroom with metal siding.

The building shown in Figure 6 is a metal frame structure with metal siding. There are a few windows, with approximately 1 m<sup>2</sup> of area each. The storeroom loading dock door and all entrance doors are made of steel. The storeroom has metal shelves along the width of the building with wide aisles between them. This structure is expected to present a large attenuation to the electromagnetic waves passing through it.

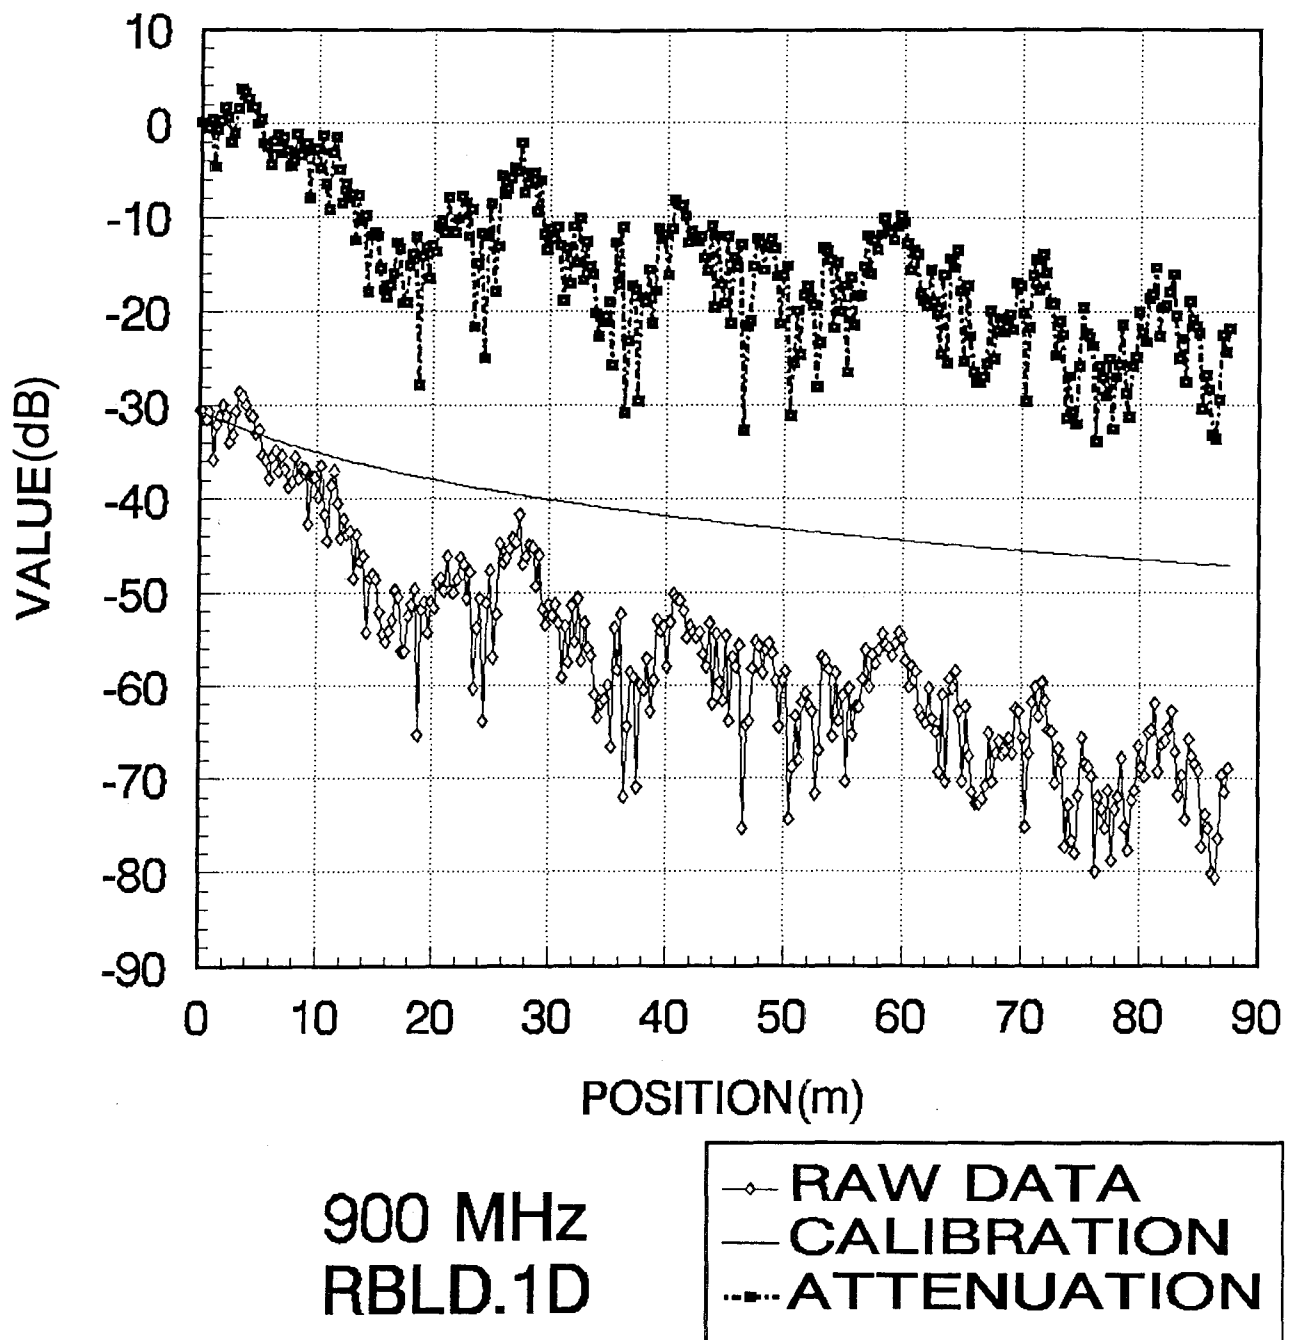
Figure 10. Raw data, free-space correction factor, and penetration attenuation versus distance for a typical 900-MHz measurement in the Radio Building.

Figures 10, 11, and 12 are examples of this process for each of the three frequencies: 900 MHz, 11.4 GHz, and 28.8 GHz. Each figure demonstrates what has been done to the data files. The raw data, free-space correction factor, and final penetration attenuation are shown in each figure. The position on the horizontal axis is the distance in meters traversed along the path.

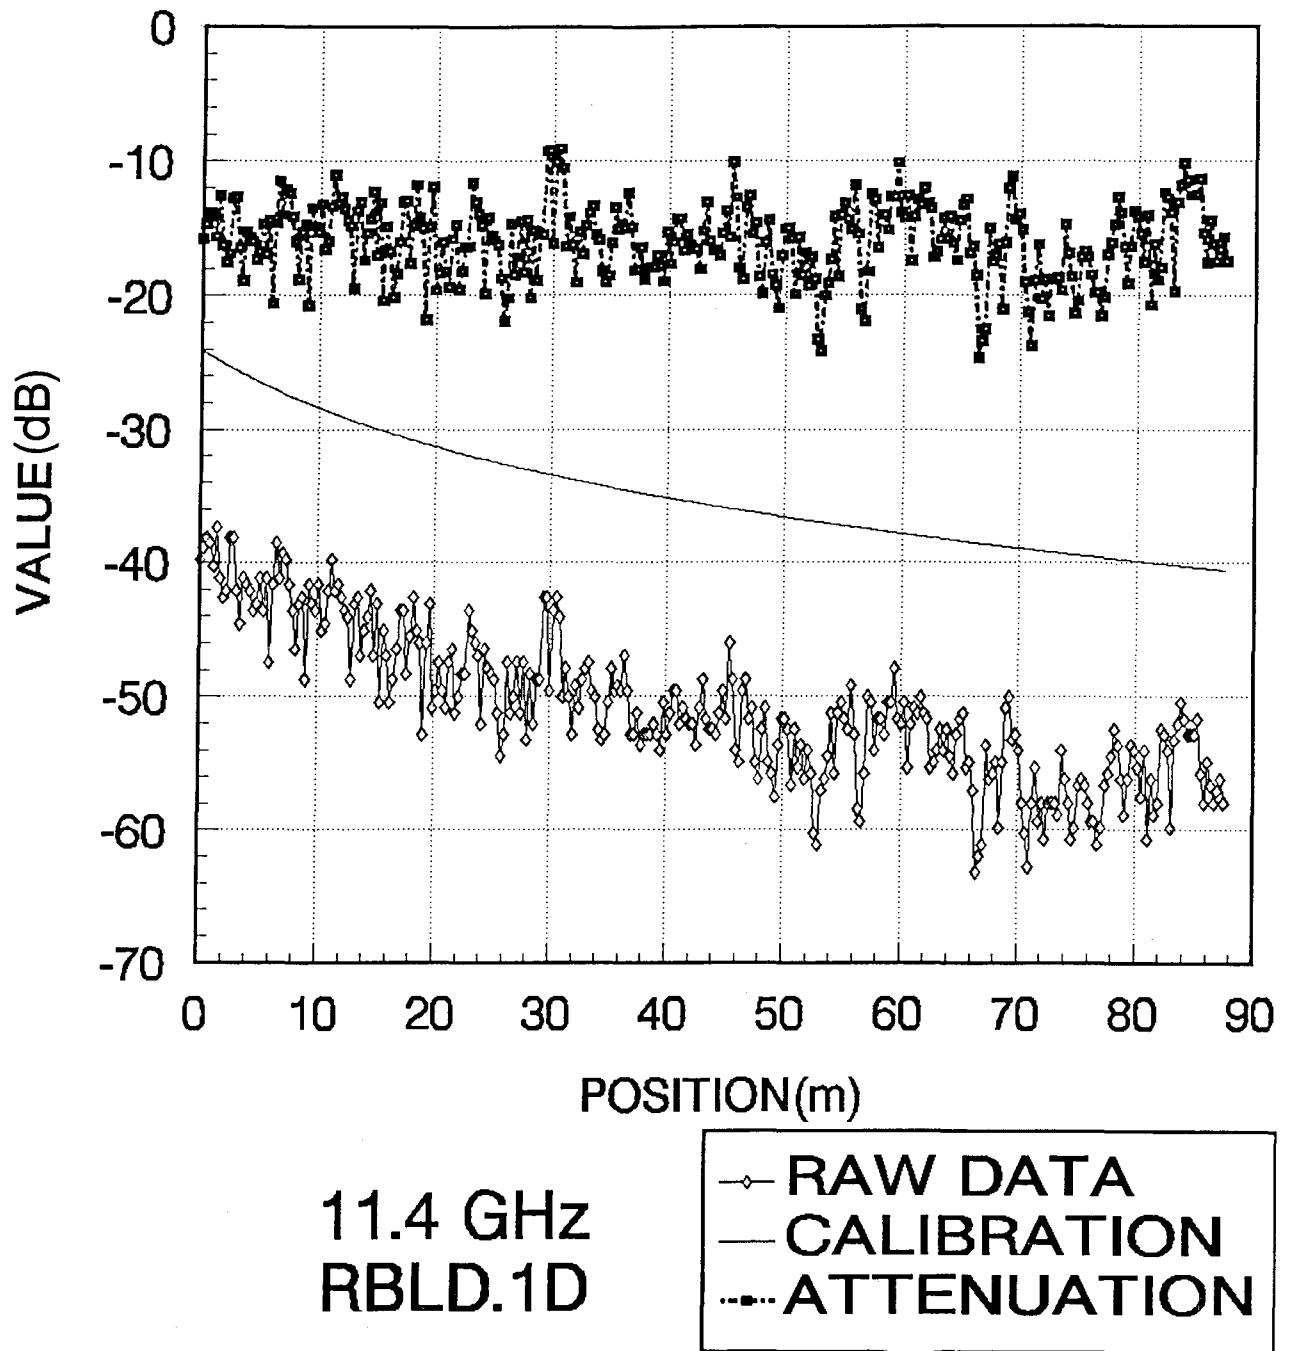
Figure 11. Raw data, free-space correction factor, and penetration attenuation versus distance for a typical 11.4-GHz measurement in the Radio Building.

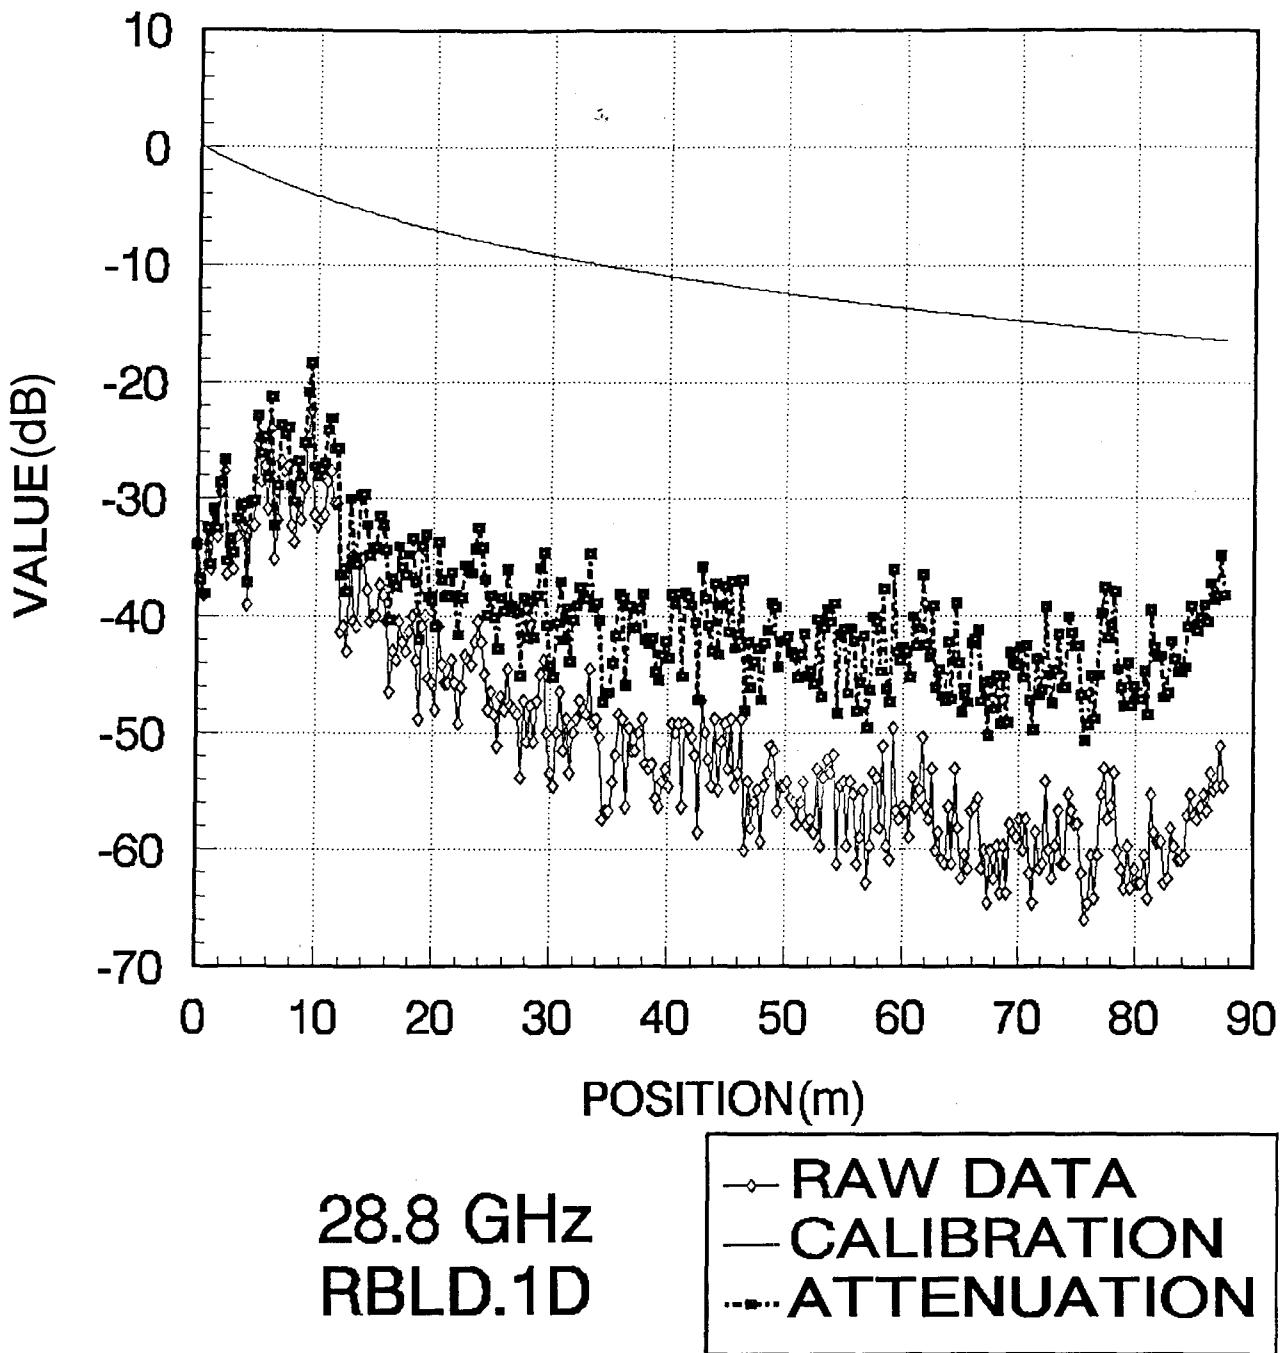
Figure 12. Raw data, free-space corection factor, and penetration attenuation versus distance for a typical 28.4 GHz measurement in the Radio Building.

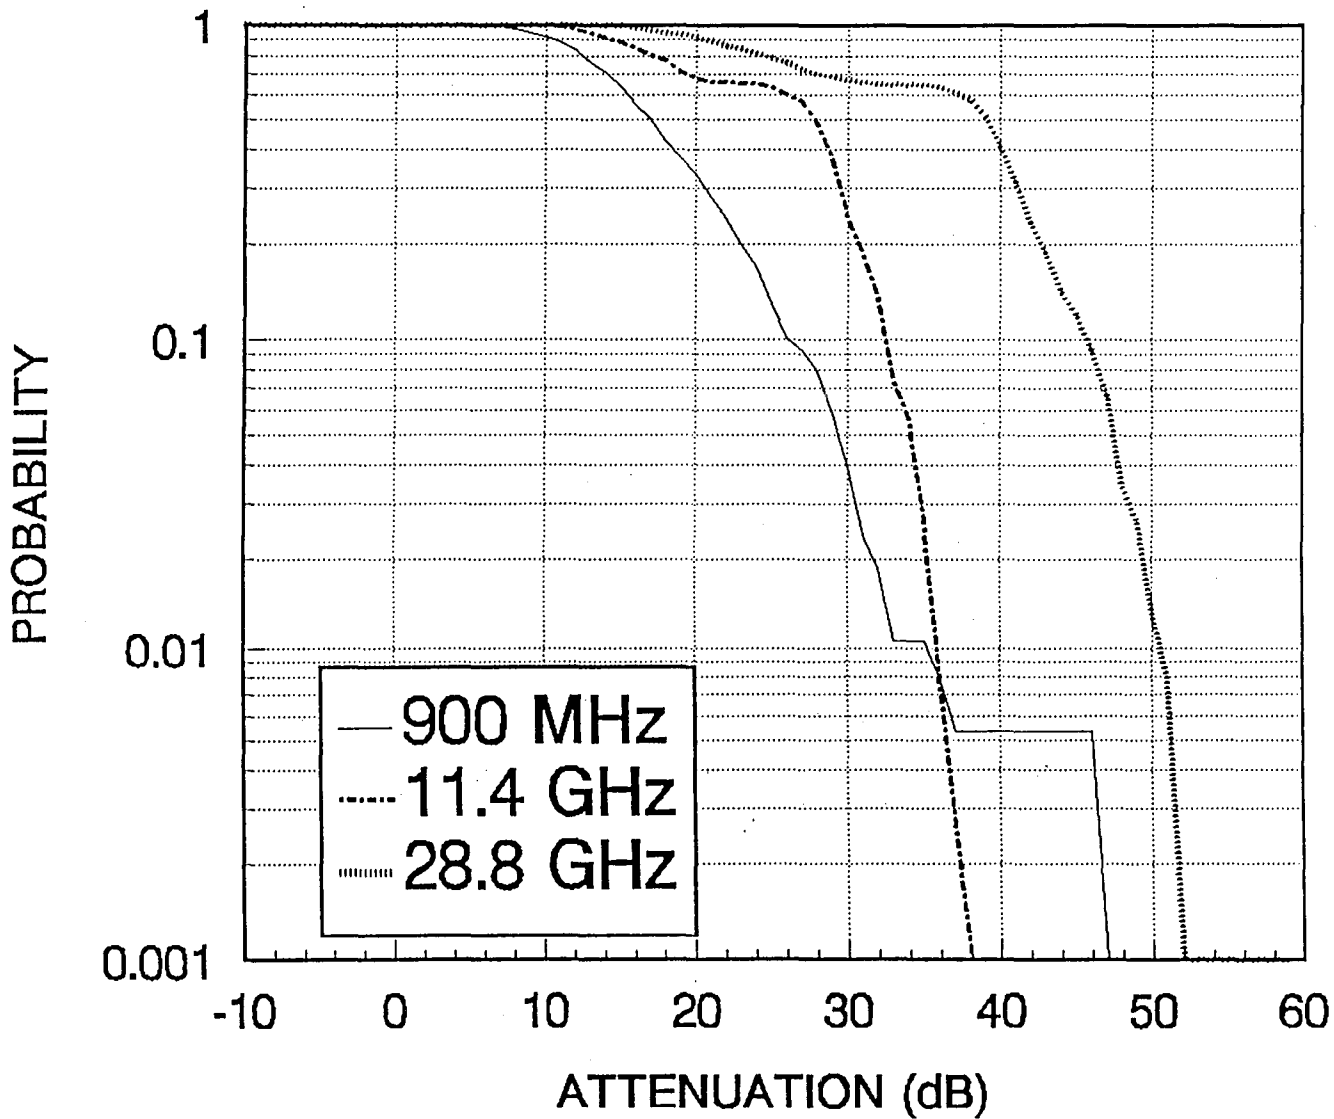
# CUM. DIST. CURVE RBLAB2

Figure 18. Cumulative distribution for all data in Radio Building with two or three walls between the transmitter and receiver.

The maximum attenuation that will be present less than a certain percentage of time can be read off these figures. This number can be used for the link margin at different link reliabilities. Table 4 has the mean attenuation and its standard deviation for all three data combinations. The means at all frequencies are greater for the two-wall case.

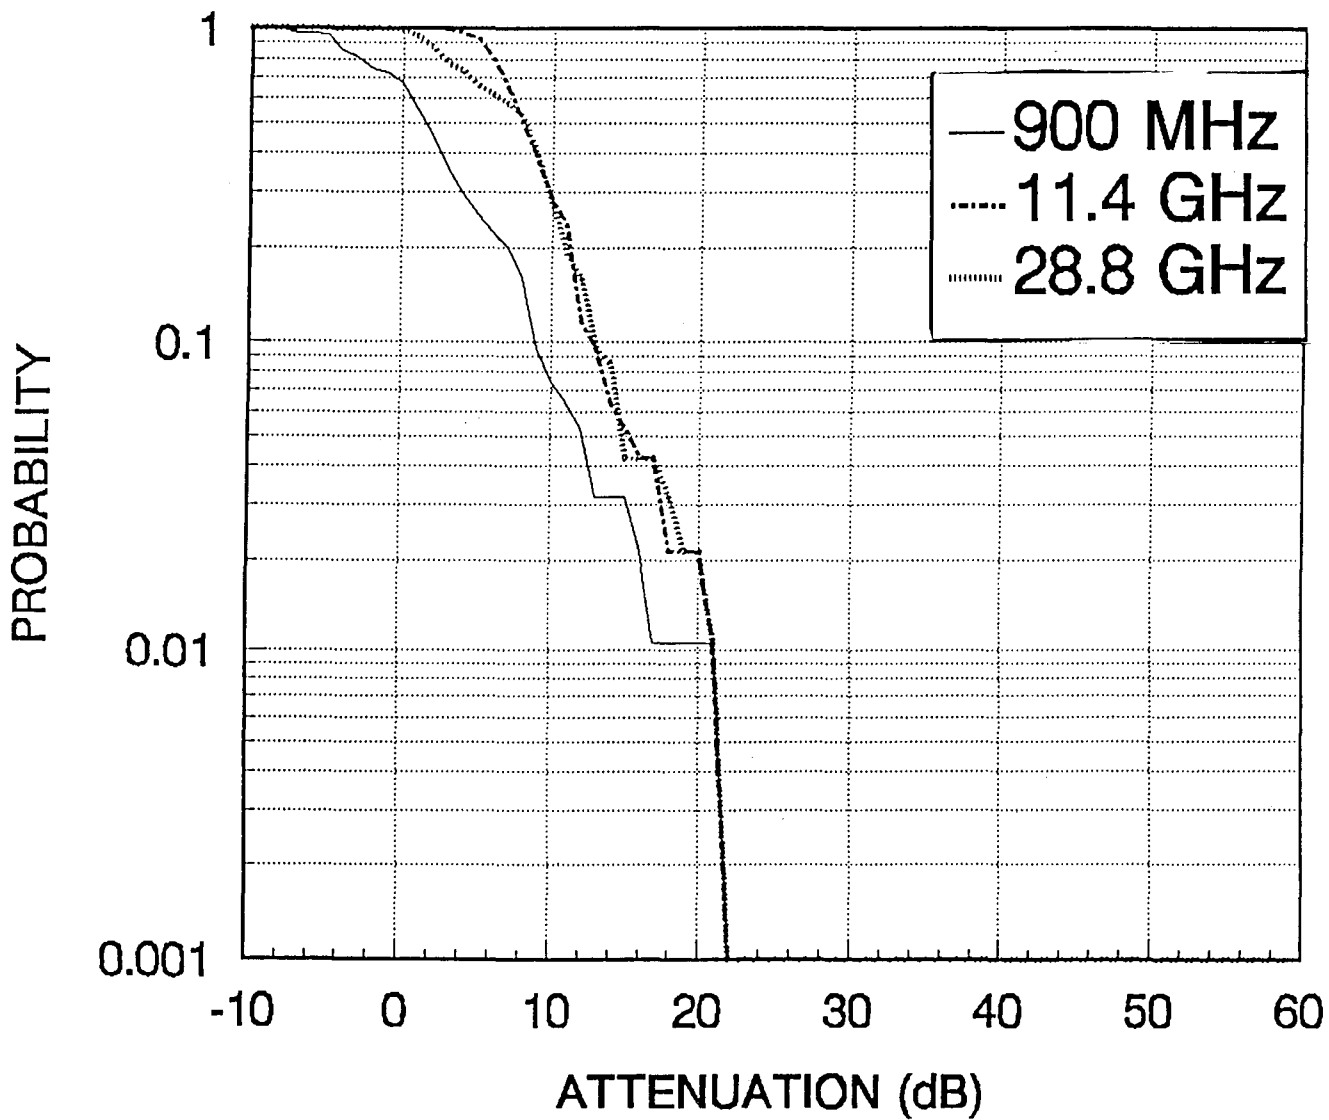
# CUM. DIST. CURVE HLFRNT

Figure 21. Cumulative distribution for all data in the private residence with one wall between the transmitter and receiver.
